## Investigation of the April 19, 2018, Communication Tower Collapse in Fordland, Missouri.

U.S. Department of Labor Occupational Safety and Health Administration Directorate of Construction

October 2018

Report Prepared by Bryan D. Ewing, Ph.D., P.E. Mohammad Ayub, P.E., S.E. Office of Engineering Services Directorate of Construction

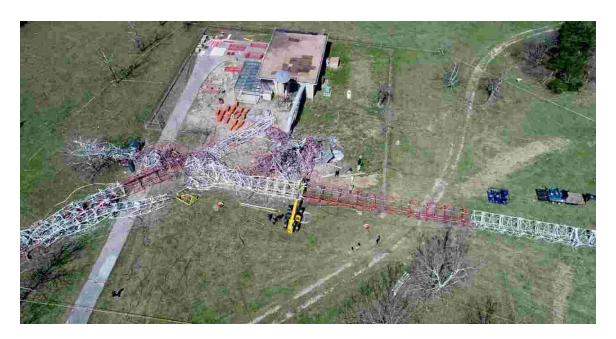
Figure 5. Collapsed Communication Tower (Google Image Search)

As shown in Figure 5, it appears that as the tower began to collapse onto itself, the tower initially fell in the southern direction. Then the tower tilted and fell over itself back in a northern direction. As the top tiers of the tower fell, they remained essentially intact. As shown in Figure

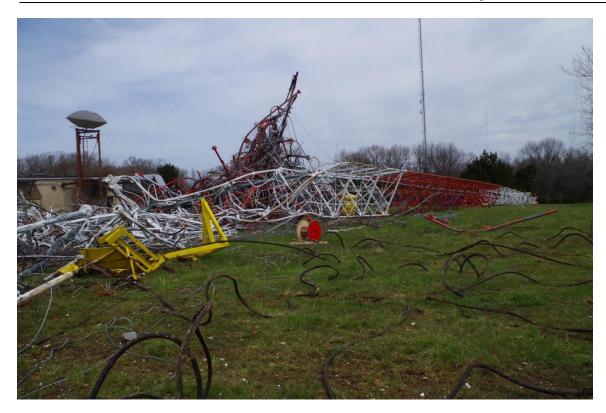
Figure 6 Top Section of Collapsed Communication Tower

6, all the guy wires disengaged from their anchor points and whipped about slashing through tree limbs and fencing. The man-basket, original and new diagonals and tools, including two comealongs were buried under the wreckage. The tower section from 90' to 120' was recovered and stored on-site for further observation. This tower section is shown in Figures 7 to 10. The slings and diagonals were found at the 105' tower elevation as shown in Figure 11. Several wires of the sling used for the come-a-long attachment to the tower panel point was severed and others were bird-nesting. A total of six bolted connections were missing. Two bolts were missing at the connection point between the two diagonals and the redundant horizontal bar. Two more bolts were missing from each gusset plate at the connection between the tower legs at the 100' elevation of the diagonals (see Figure 11). This was consistent with witness statements that the crew was working on the final third bay of diagonals at the 105' elevation at the time of the incident. The redundant bar and the tower leg appeared to have buckled.

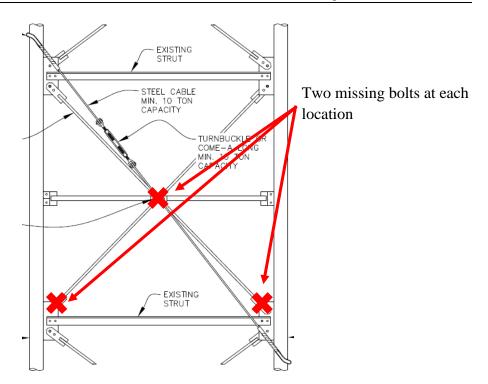
- 2) The cause of the communication tower collapse was the weakening of the compressive strength of the tower legs by removing the bolts at the connection of the diagonals to the horizontal redundant. The compromised redundant effectively doubled the unbraced length of the tower leg which reduced the compressive capacity of the tower leg.

Figure 11. Missing bolts at the 105' Tower Elevation

TCI's erection drawings states that the diagonals must be replaced one at a time. However, in order to replace a diagonal, the two bolts on each end of the diagonal and the two bolts at the diagonal's mid-span must be removed. The removal of the bolts at the mid-span, however, results in doubling the unbraced length of the tower legs and redundant from five to ten feet.

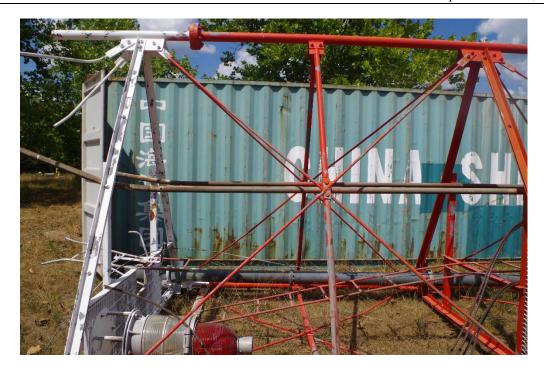
A representative section of the 105' tower elevation is shown in Figure 12. Figure 12 is a photograph of one of the tower bays of the top section of the tower that remained essentially intact after the collapse. The tower legs are braced by the diagonal rod members and the horizontal (appears vertical in the photograph as the tower is on its side) redundant. The typical tower bay is 10' wide by 10' tall. Therefore, this configuration of the bracing members creates unbraced lengths of five feet for the tower legs and redundant. The diagonals and the redundant were connected with two bolts at their mid-span as shown in Figure 13.

Figure 12. Representative Section from the Top of the Tower

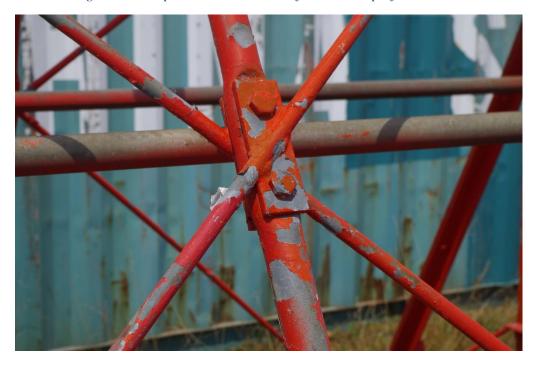
Figure 13. Bolted Connection between Diagonals and Redundant Horizontal

This doubling of the unbraced length creates three problems for the redundant member. First, the redundant member exceeds the allowable slenderness ratio for main compression members other than leg members and for secondary members (200 and 250 respectively) as outlined in ANSI/TIA-222-G. The resultant slenderness ratio of the redundant member without the bolted connection at its mid-span is 274. Second, the unfactored compressive resistance is reduced from 32 kips to 8 kips. This 75% reduction of compressive strength created the third problem for the redundant member. The redundant no longer satisfied the ANSI/TIA-222-G requirement for minimum bracing resistance for the tower legs. ANSI/TIA-222-G requires that the strength of the brace is at least 1.5% of the axial design compressive force of the supported member. Therefore, the unbraced length of the tower legs has doubled to ten feet.

The ANSI/TIA-222-G design strength of the tower legs was reduced by 68% due to the doubling of the unbraced length. The tower legs require a minimum bracing resistance of approximately 13 kips. However, the horizontal redundant member is only capable of providing 8 kips. The resultant unfactored design strength of the tower legs reduces from 865 kips to 279 kips. The total dead load from the guy wires and the weight of the tower above the 105-foot elevation is 316 kips. Furthermore, any incidental wind load would increase the compressive load on some of the tower legs. The overstressing of the tower legs could have been a reason for why some of the diagonals did not fit and required re-boring of the bolt holes.

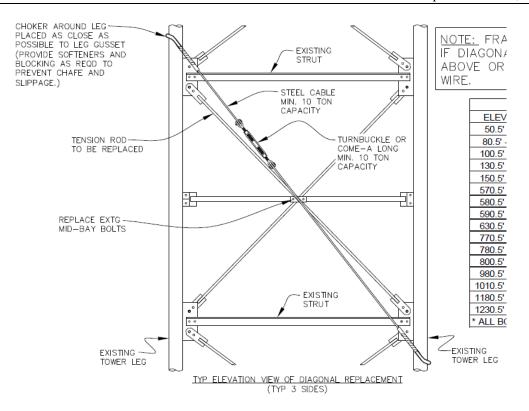
1) TCI's suggested diagonal replacement procedure was flawed in that it compromised the effectiveness of the integrated surrounding braces and the load bearing capacity of the

The diagonal replacement procedure is described on sheet E-5 of TCI's erection drawings document and is partially shown in Figure 14. The diagonal replacement procedure requires the use of a come-a-long to eliminate the tensile forces in the diagonal to facilitate the removal of the diagonal. TCI requires the use of a come-a-long with a ten-ton capacity. However, Lemay used a come-a-long device (Griphoist/Tirfor® T-532D) with a rated working load of 8,000 pounds (4 tons). An identical model come-a-long used on-site is shown in Figure 15. The come-a-long used on the tower is shown in Figure 16 while in the debris field and which was recovered later is shown in Figure 17.

Figure 14. TCI Diagonal Replacement (E-5)

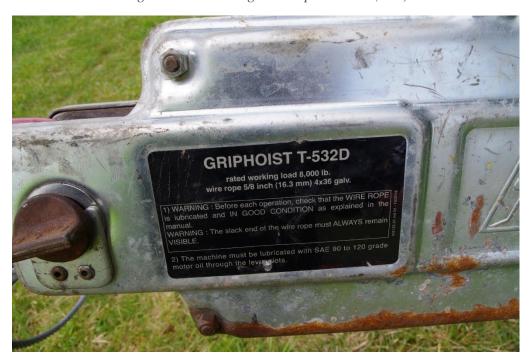
- 3) Lemay used an undersized come-a-long while removing the diagonal braces.
- 4) Lemay failed to provide the design of the required temporary frame for diagonal replacement above or below a guy level. TCI failed to confirm the use/design of a temporary frame as TCI is required to approve the adequacy of the temporary frame prior to diagonal replacement according to TCI's construction documentation.

Figure 15. Lemay Come-a-long Used On-site

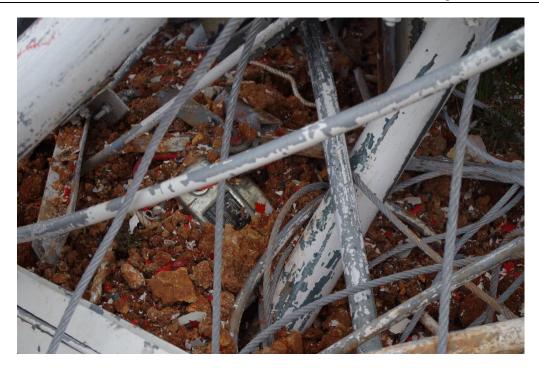
Figure 16. T-532D Come-a-long in Debris

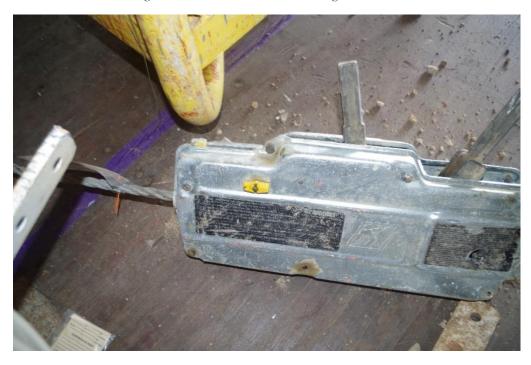
Figure 17. T-532D Come-a-long Salvage from Debris
