September 30, 2015

From: John Heggie, Acting Chief Building Official and Executive Director
Toronto Building

Re: **Review of Trump Tower Spire Response**

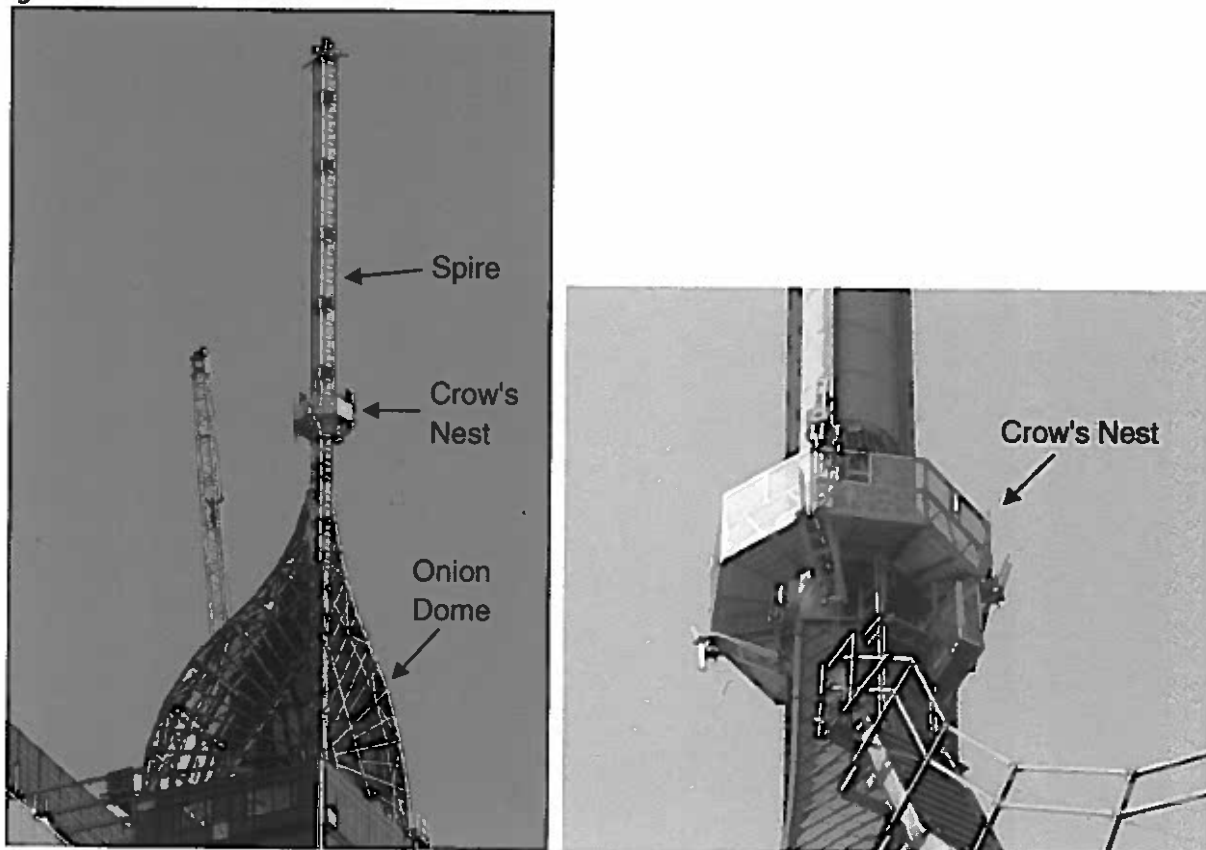
Figure 1

The location and recent history of the Trump Tower in downtown Toronto is widely known. While it is assumed the reader has a general knowledge of the building, the following elements are worth noting: i) the Tower consists of 57 floors of residential occupancy; ii) the lower 34 floors are hotel use and the upper 23 floors are condominium use; and, iii) the element in question is the "spire" located on the roof level of building. (See Figure 1)

The spire is approximately 25m in height from the top of a skylight structure called the onion dome, and extends approximately 20m down to the attachment point on the roof of the building, for a total height of 45m. It is constructed of structural steel components whose design was engineered by Halcrow Yolles and fabricated, including shop drawing preparation, by Beauce-Atlas, a firm based in the province of Quebec.

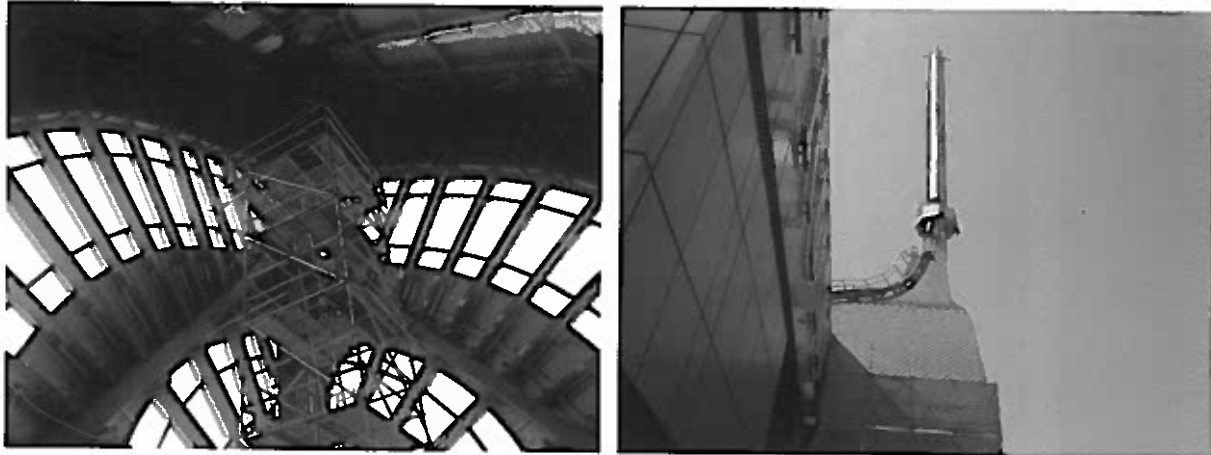
Figure 2

Concern regarding the spire was first reported by a crew hired by the building operators to carry out repair work to the roof flashing on the onion dome. The crew initially reported hearing a loud metallic scraping noise while they were inside the building under the onion dome area and around the location of the spire of the 57th floor penthouse suite. (See Figure 2)

The crew exited the suite to the balcony area (see Figure 2) where they witnessed the spire structure swaying and immediately reported it to the building's chief engineer. Upon conferring with the crew who reported witnessing the spire sway approximately 1.2m (4'0"), and his own eye-witness account of the spire, the Trump Tower's maintenance engineer, [REDACTED] proceeded to contact and advise the building's security director of the issue. In the interest of public safety, the security director contacted City of Toronto emergency services. Toronto Police Services have confirmed that they received the initial call at 7:30 am.

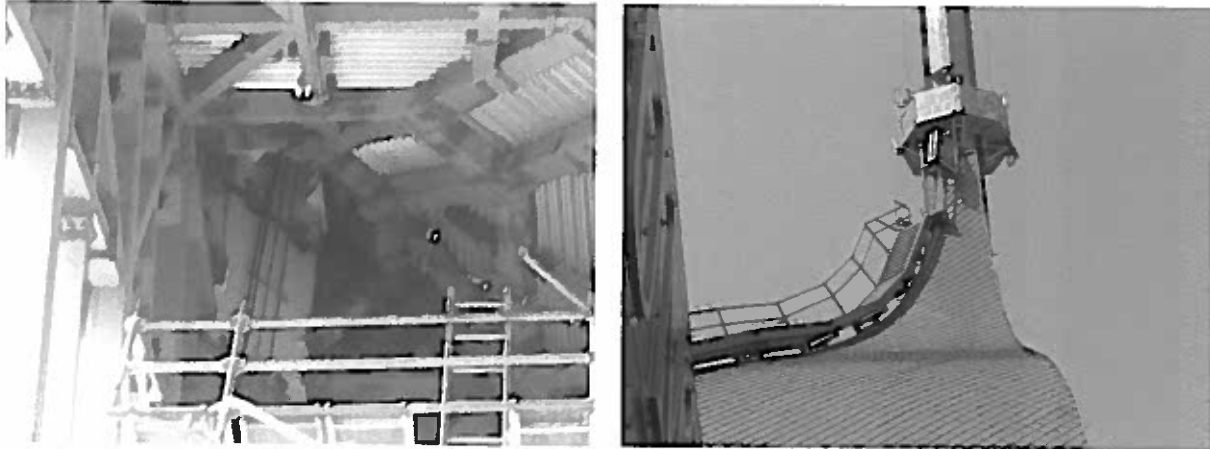
Figure 3

In order to properly inspect the spire within the onion dome, the Beauce-Atlas engineer needed to erect additional scaffolding to complete his review. The Beauce-Atlas engineer was limited in their ability to conduct visual inspections due to the design of the onion dome. The height of the dome exceeded the reach of the scaffold and the inspection of the exterior portions of the spire was delayed due to concerns with the access ladder to the crow's nest. (See Figure 3)
