Safety Order and Notification of Penalty

Inspection Number: 311847461
Inspection Date(s): 05/17/2008 - 08/19/2008
Issuance Date: 09/04/2008

Inspection Number: 311847461
Inspection Dates: 05/17/2008 - 08/19/2008
Issuance Date: 09/04/2008

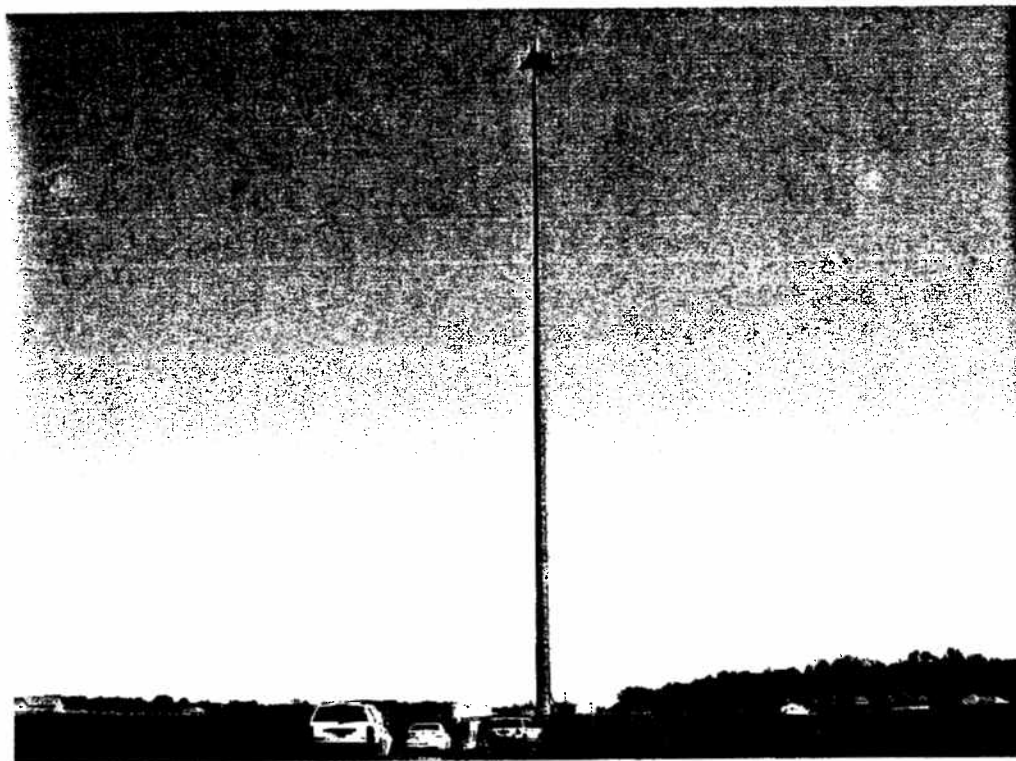
IOSHA Complaint or Inspection Number: _____ Photo ID Number: DSCN4065

Description of Hazard / Abatement: This tower is owned by SBA. SBA leases the ground from the neighboring landowner. SBA rents space on their towers to cellular phone carriers, in this case, AT&T. AT&T hires contractors to install, maintain, replace, etc., the equipment on the towers. In this case, AT&T hired General Dynamics to oversee upgrade of existing services on a series of cell towers. General Dynamics subcontracted All Around Towers to perform the work on this particular tower. The crew was at the very beginning of this process when the incident occurred.
