## Investigation of the April 19, 2018, Communication Tower Collapse in Fordland, Missouri.

U.S. Department of Labor Occupational Safety and Health Administration Directorate of Construction

October 2018

Report Prepared by Bryan D. Ewing, Ph.D., P.E. Mohammad Ayub, P.E., S.E. Office of Engineering Services Directorate of Construction

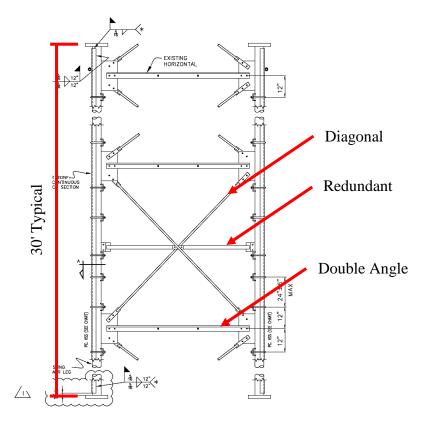
Figure 2. Typical Bracing Elevation of Tower Legs

The 1,891-foot-tall guyed communication tower is constructed of 10-foot wide triangular sections. The legs of the tower consisted of 63 sections of solid round steel ranging in diameter from 4½" to 3¼" that were approximately 30 feet long. The lower 34 leg sections were constructed from high strength alloy steel with a design yield strength of 95 ksi. The design yield strength of the remaining leg sections was 47 ksi. The legs are connected by numerous angle struts, solid rod diagonals and horizontal redundants as shown in Figure 2. Although Figure 2 only shows one side, all three sides of the tower are similar. The angle struts consisted of double back-to-back A36 grade steel angles. The sizes of the angles vary and were either L3x2x<sup>1</sup>/<sub>4</sub> or L2<sup>1</sup>/<sub>2</sub>x2x<sup>1</sup>/<sub>4</sub>. The solid rod diagonals were fabricated from A36 grade steel and vary in diameter from 3/4" to 11/4". The horizontal redundants were 13/4" diameter solid A36 steel rods. The horizontal redundants were narrowed at its mid-span to accommodate the splice plates of the crossing diagonals. Both diagonals and the redundant were secured to each other with two through bolts. Note that Figure 2 shows the recommended split pipe reinforcement of the tower legs, but these split pipe reinforcements were not in place at the time of the incident. The 30-foot tower leg sections were field spliced together with six A325 bolts through factory fabricated flange plates at each end of the leg. The tower was stabilized by nine levels of guy wires. Each level had three guy lines (1 for each of the principal triangular directions of the tower). The diameter of the guy lines varied from 1-1/16" to 1-9/16" with a range of initial tensile forces between  $\pm 15$  kips to  $\pm 33$  kips depending on the temperature. A typical cross section of the tower and tower elevation are shown in Figures 3 and 4, respectively.

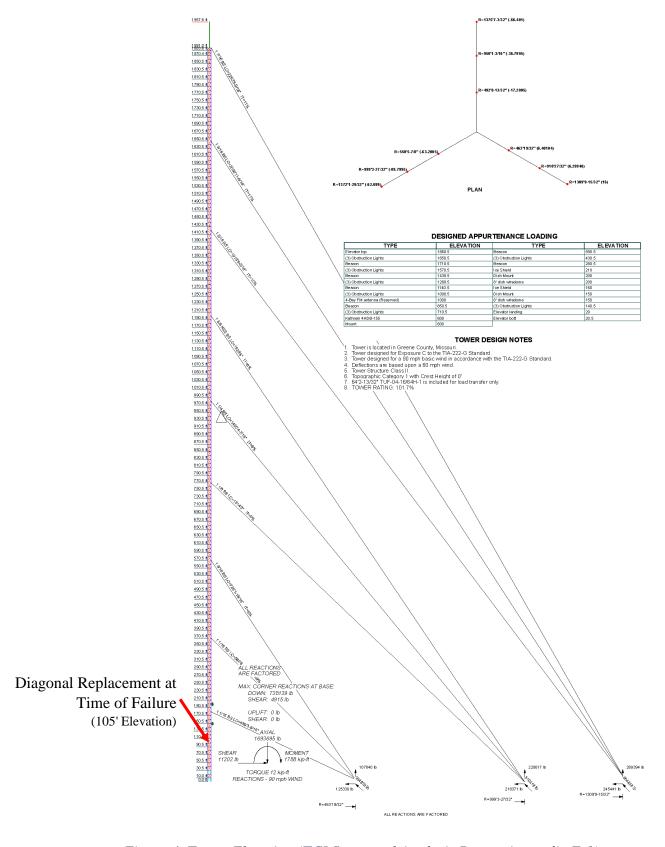
Figure 4. Tower Elevation (TCI Structural Analysis Report Appendix E-1)

TCI's May 19, 2017 structural analysis of the communication tower concluded that structural modifications were necessary for the tower to comply with the wind and ice loading requirements of ANSI/TIA-222-G. TCI recommended to replace one level of guy wires, reinforce 34 tower leg sections, replace 25 bays of diagonals and reinforce one level of horizontal struts. Lemay was contracted to perform the recommended structural modifications.
